Test Intention:

In test 2233 we want to investigate the lifespan of a CF5.10.25 in an e-chain with a 100mm radius on the short way.

Series / No: CF5

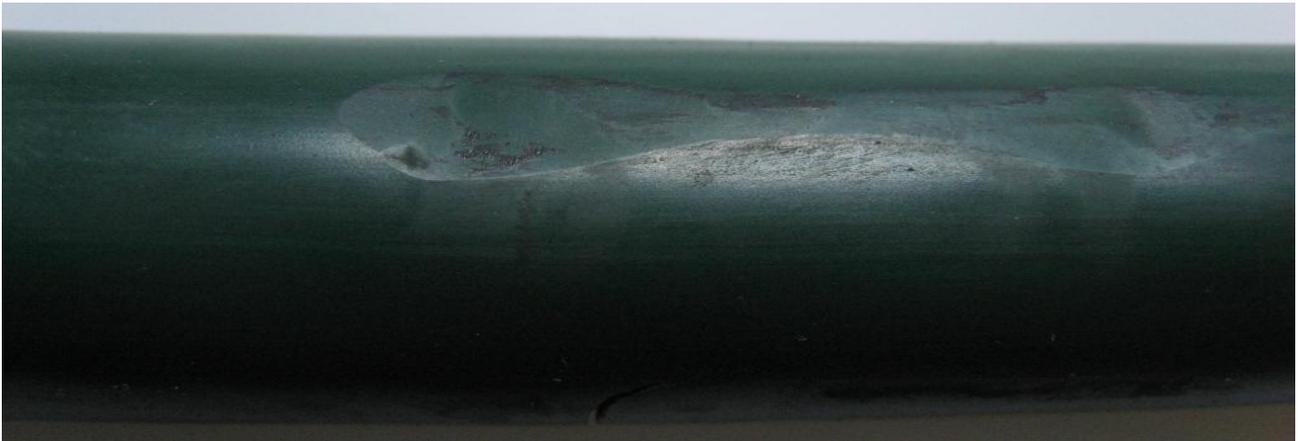
The outer jacket

The condition of the cable no. 1.1 (CF5.10.25) after 41.538.456 strokes

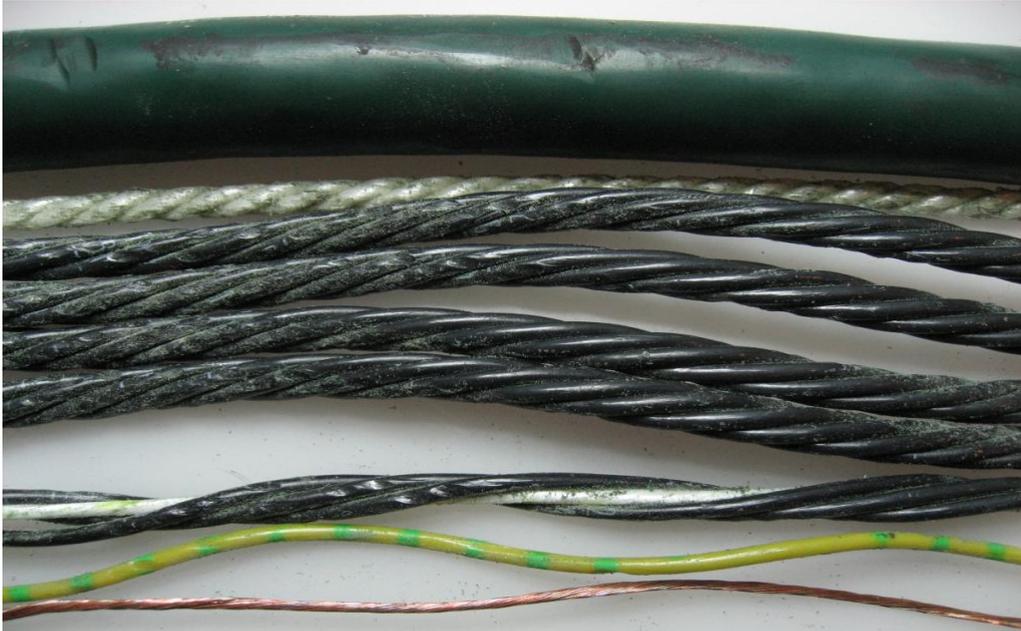
Overview of the dissected pieces of cable of no. 1.1 CF5.10.25 after 41.538.456 strokes

Strokes	41.538.456
Condition outer jacket	O.K.
Condition centre element	O.K.
Bundle	
Condition core insulation	O.K.
Condition conductor	O.K.

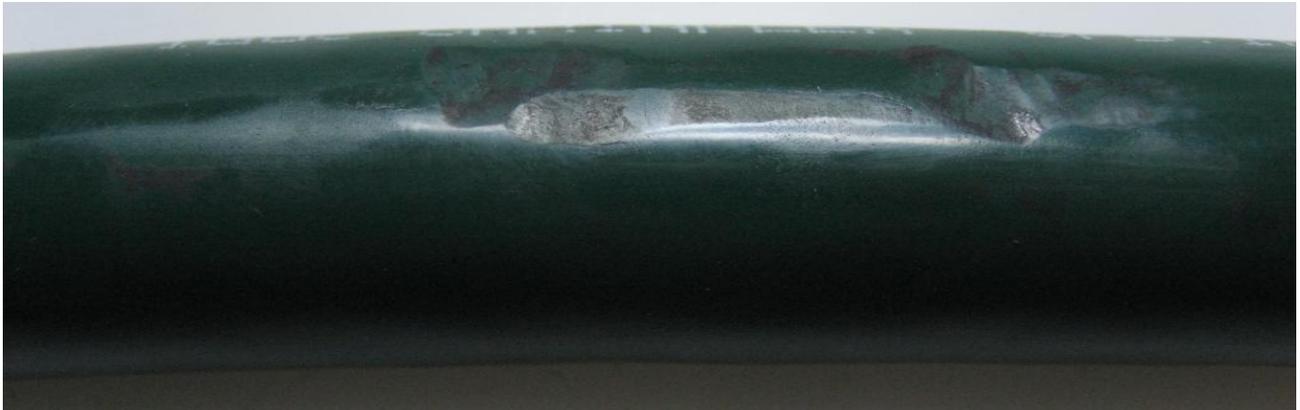
The outer jacket

The condition of the cable no. 1.2 (CF5.10.25) after 41.538.456 strokes

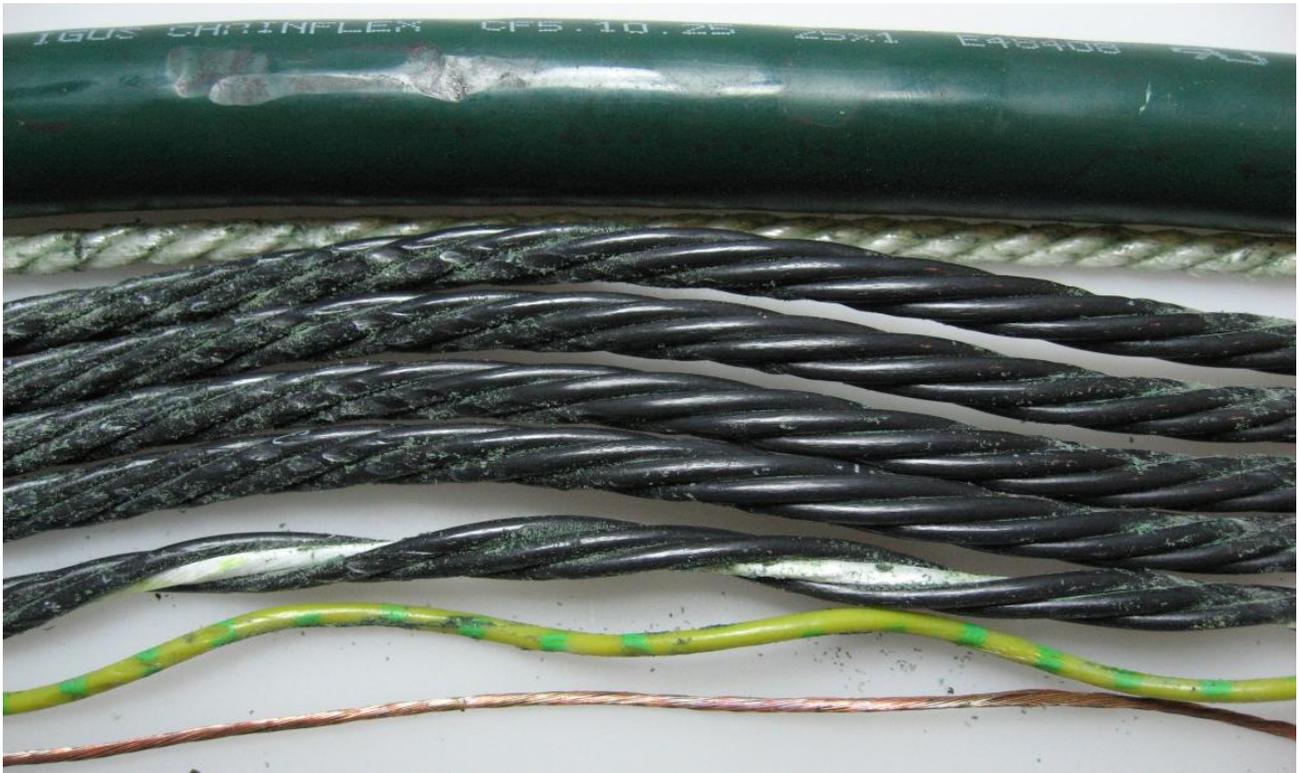
Overview of the dissected pieces of cable of no. 1.2 CF5.10.25 after 41.538.456 strokes

Strokes	41.538.456
Condition outer jacket	O.K.
Condition centre element	O.K.
Bundle	
Condition core insulation	O.K.
Condition conductor	O.K.
